COATED-FABRIC TANK LIFE EXTENSION STUDIES

INTERIM REPORT
TFLRF No. 312

G.E. Fodor
U.S. Army TARDEC Fuels and Lubricants Research Facility (SwRI)
Southwest Research Institute
San Antonio, Texas

May 1996

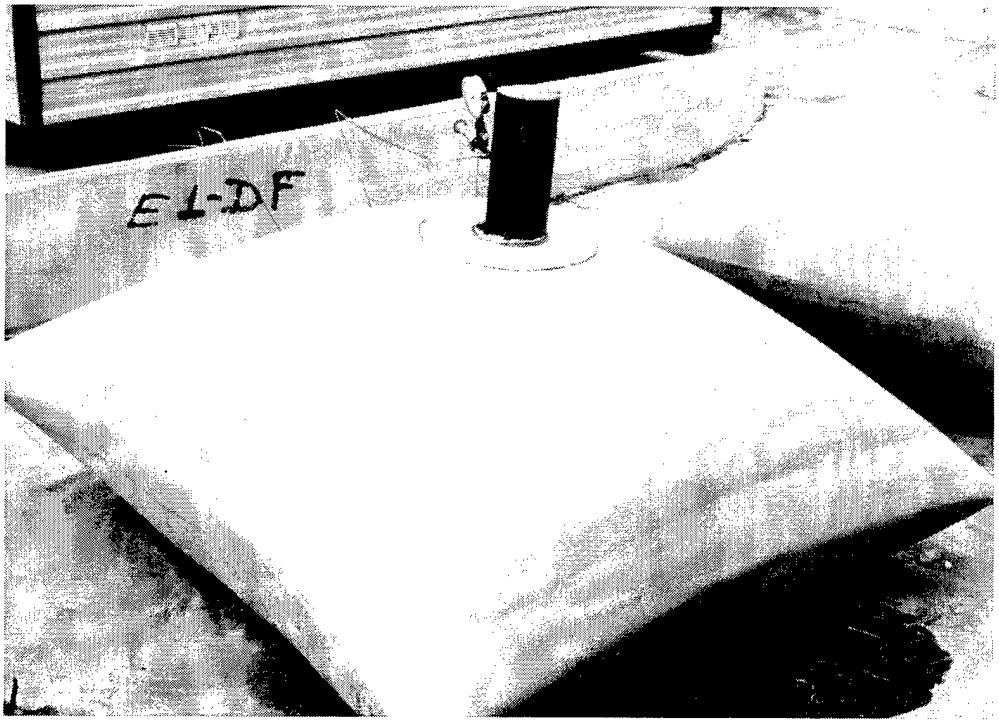
Photograph No. 1. **Initial condition of the E-1 minitank containing diesel fuel**

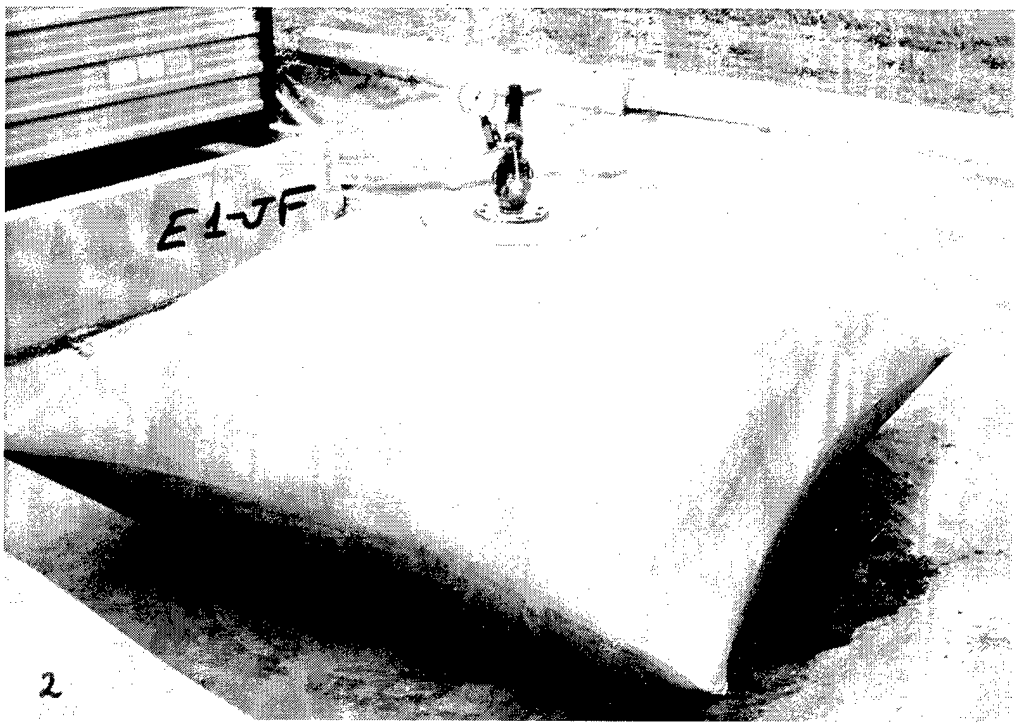
Photograph No. 2. **Initial condition of the E-1 minitank containing turbine fuel**

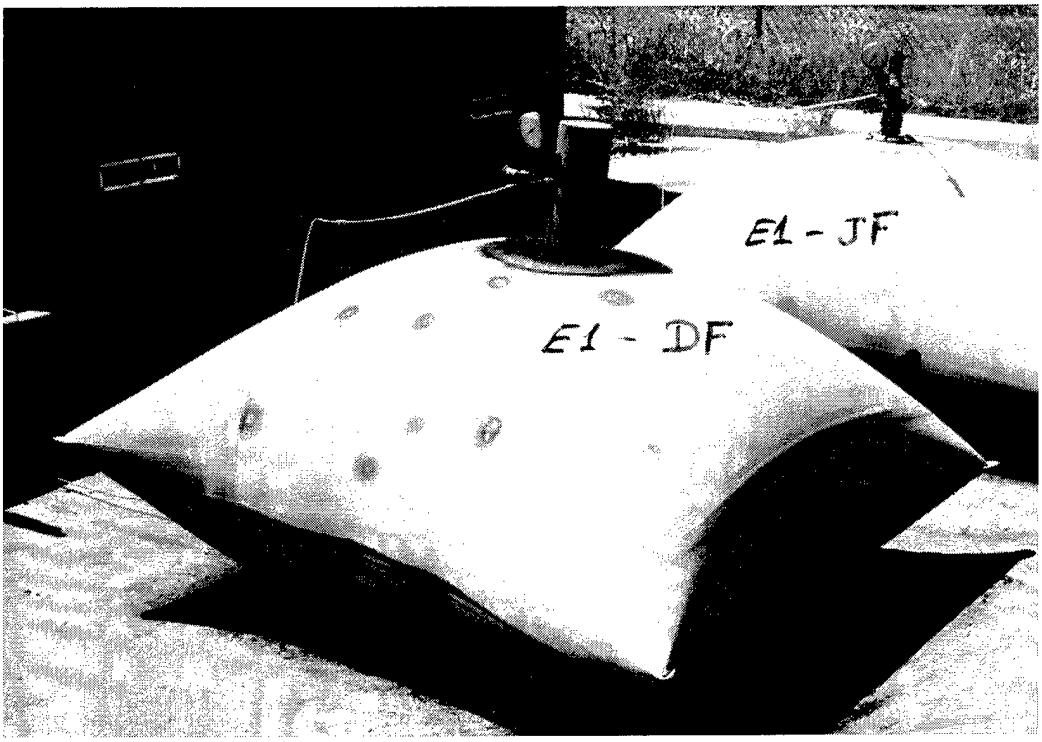
E-1 minitanks were filled with the referee grade diesel fuel during October 1991 and were pressurized to 60 lb/in. seam stress after a two-week observation period. After seven months of exposure, these products were depressurized, emptied, and the manufacturer repaired the O-rings. The tanks were out of service for two months, after which time they were refilled and repressurized. Except for some fuel-related surface discolorations, these tanks are still under test conditions after over 53 months of exposure. The fabric surface of E-1 is smooth, with several approximately 10- to 15-cm diameter visible fuel-induced discolorations. Photograph Nos. 1 and 2 in Appendix B show the initial condition of the diesel fuel- and turbine fuel-filled minitanks, respectively. Photograph No. 3 shows the excellent condition of these pressurized tanks after 53 months under test conditions.

Photograph No. 3. Condition of pressurized diesel fuel- and turbine fuel-filled E1 minitanks after 53 months under test conditions

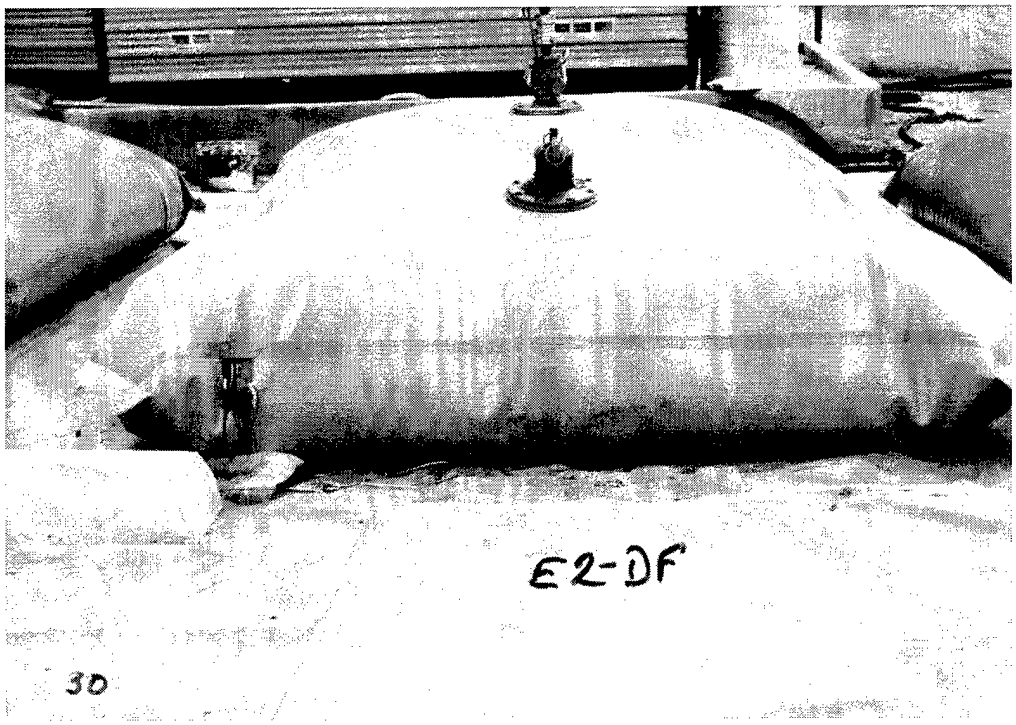
E-2 minitank began to display signs of approaching failure immediately after filling with diesel fuel, as shown in Photograph No. 4. All the seams were flooded with fuel, and there were several blisters in the seam sections. Leaks were clearly evident at all four corners. Patches of fuel appeared along the perimeter of the tank on top of the berm liner. To alleviate the safety

and environmental hazards, the tank was surrounded by "Hazorb" spill control pillows to soak up the puddles of fuel along the periphery of the tank. (These spill control pillows, replaced as needed around the tanks, are filled with inert foamed sand and adsorb acidic, caustic, solvent, and oil spills.) Photograph No. 5 shows the soiled spill control pillows around this minitank. Twenty-four hours later, a stream of diesel fuel was found escaping from this tank, as seen in Photograph No. 6. At this time, the tank was emptied to avoid environmental and safety hazards.

Photograph No. 4. Evidence of failure on E-2 minitank containing diesel fuel

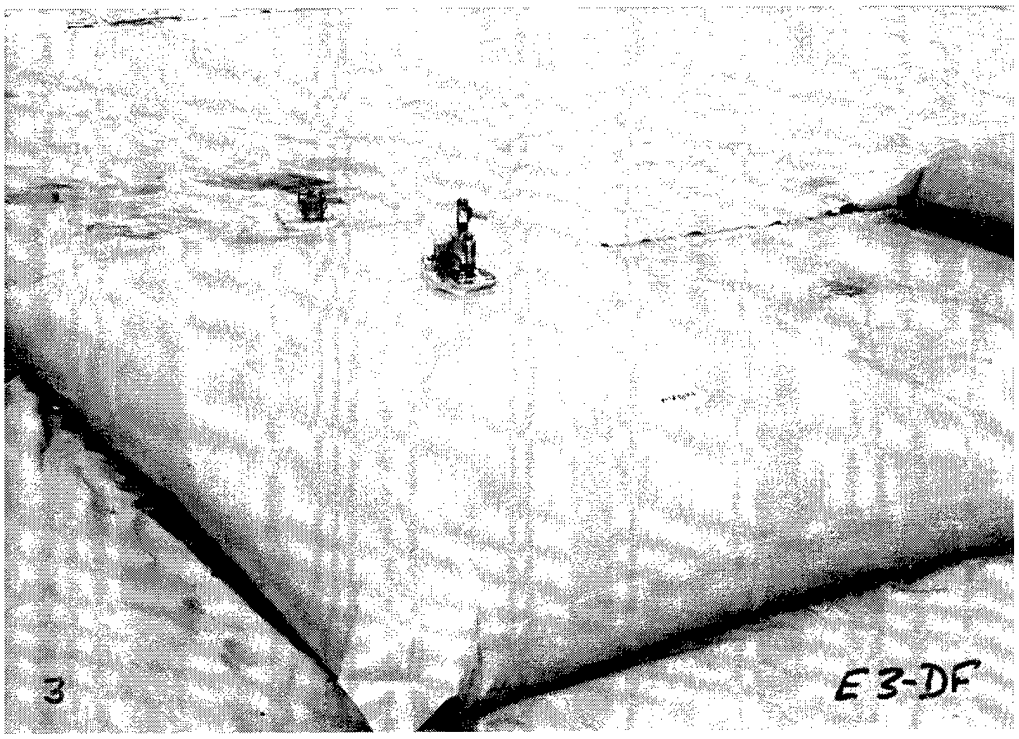
E-3 minitank is shown in Photograph No. 7 immediately after it was filled with diesel fuel. Within two months of storage, this tank had to be emptied and withdrawn from further testing due to excessive fuel leakage at seam areas. Photograph No. 8 illustrates one such area. Minitank of E-3 is shown in Photograph No. 9 one day after it was filled with turbine fuel. Except for minor leaks from the seam areas, this tank survived for 22 months of outdoor exposure before it also had to be emptied of fuel due to an over 100-cm long fully separated seam section, as shown in Photograph No. 10. The empty tank was allowed to remain at the test site. Within one year after this picture was taken, most of the upper surface of this tank suffered from environmentally induced major delamination of the coating material from the nylon fabric, demonstrating full degradation of this material, as shown in Photograph No. 11.

Photograph No. 7. **E-3 minitank immediately after being filled with diesel fuel**

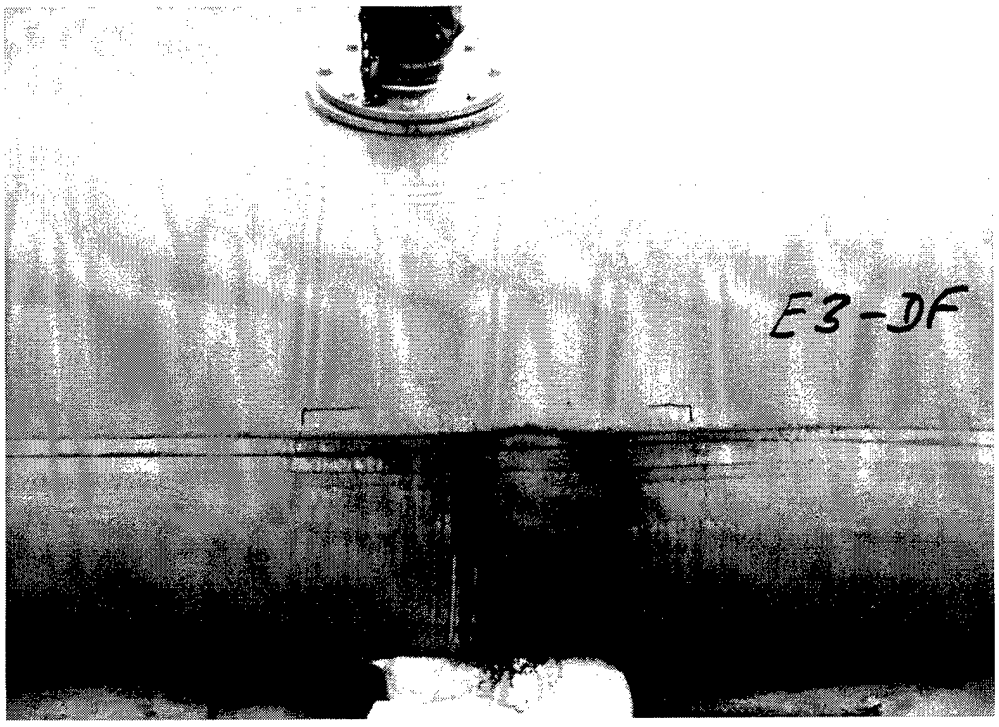
Photograph No. 8. **Evidence of diesel fuel leakage from E-3 minitank**

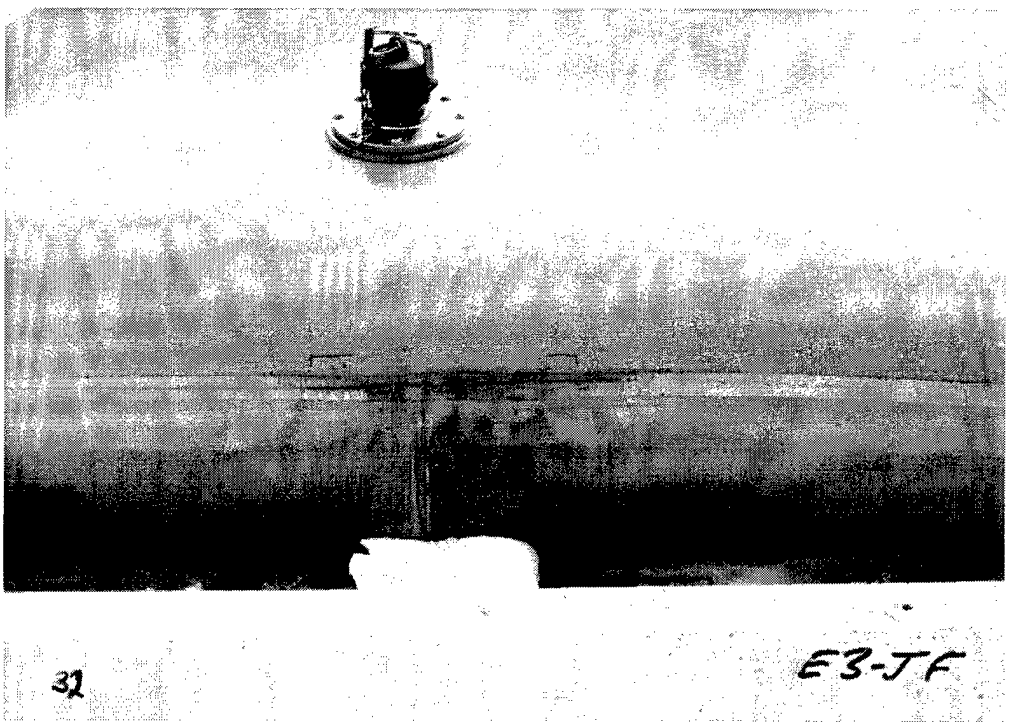
Photograph No. 9. **E-3 minitank one day after being filled with turbine fuel**

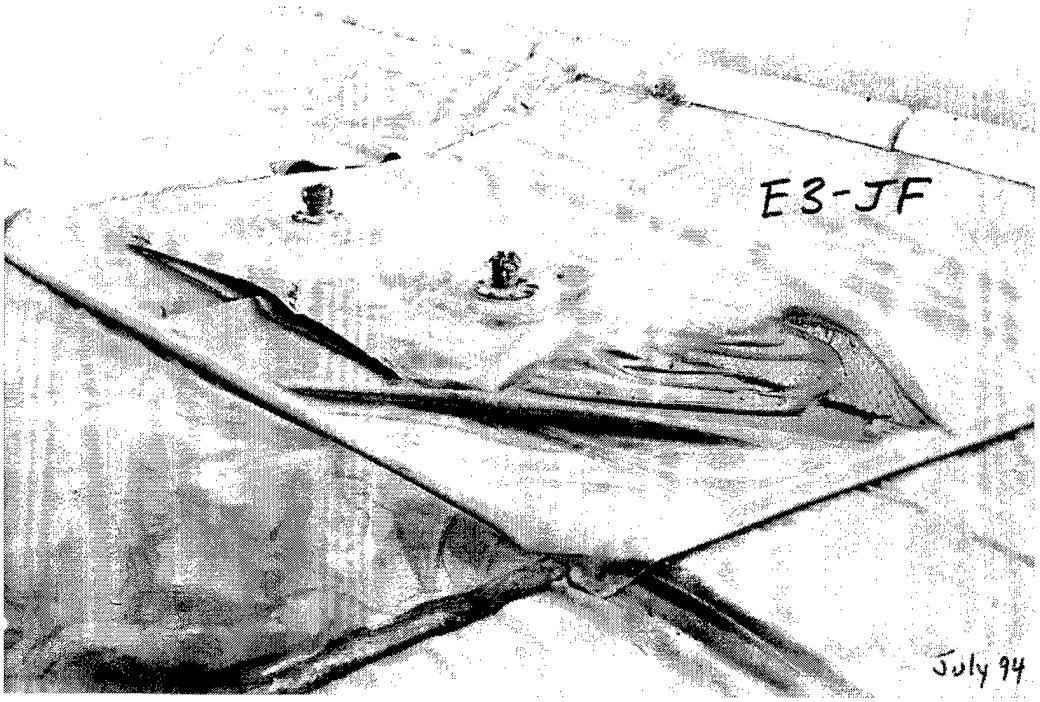
Photograph No. 10. **Separated seam section of E-3 minitank containing turbine fuel after 22 months of outdoor exposure**

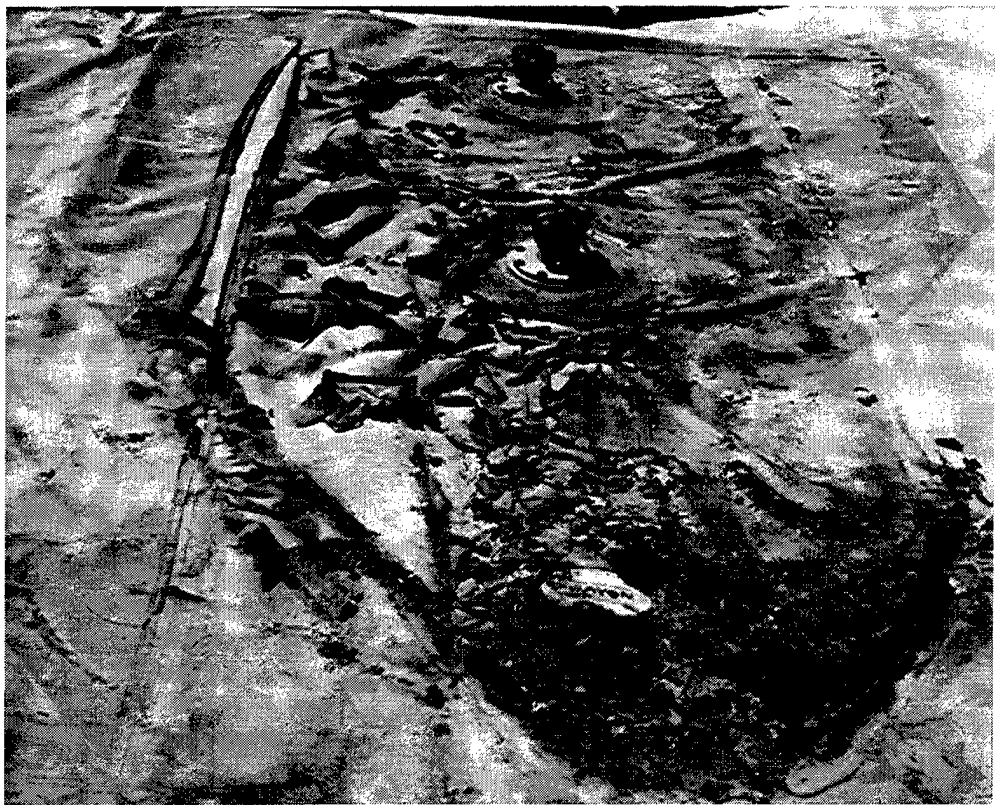
Photograph No. 11. **Full degradation of E-3 minitank containing turbine fuel**

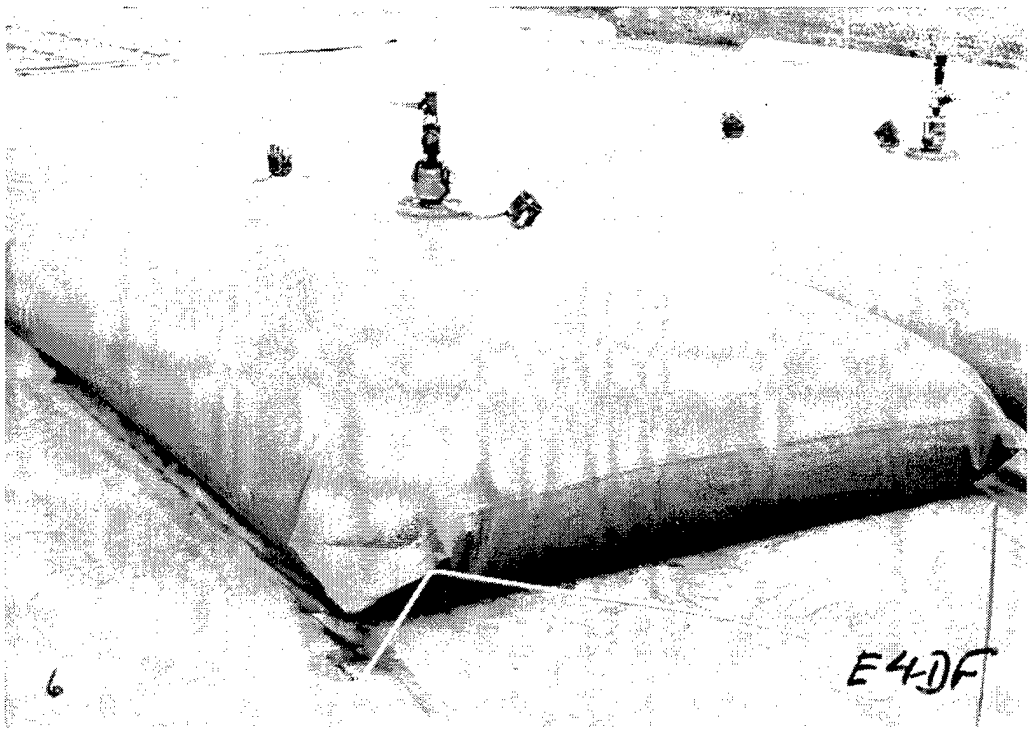
E-4 minitank, filled with the referee grade diesel fuel during August 1992, is shown in Photograph No. 12. This tank failed after 10 months of exposure and had to be taken out of service due to excessive leaking from seam and corner areas, as shown in Photograph No. 13. Note the severe darkening of the outer surfaces of this tank.

Photograph No. 12. **E-4 minitank filled with referee grade diesel fuel**

Photograph No. 13. Evidence of seam and corner leakage from E-4 minitank containing diesel fuel

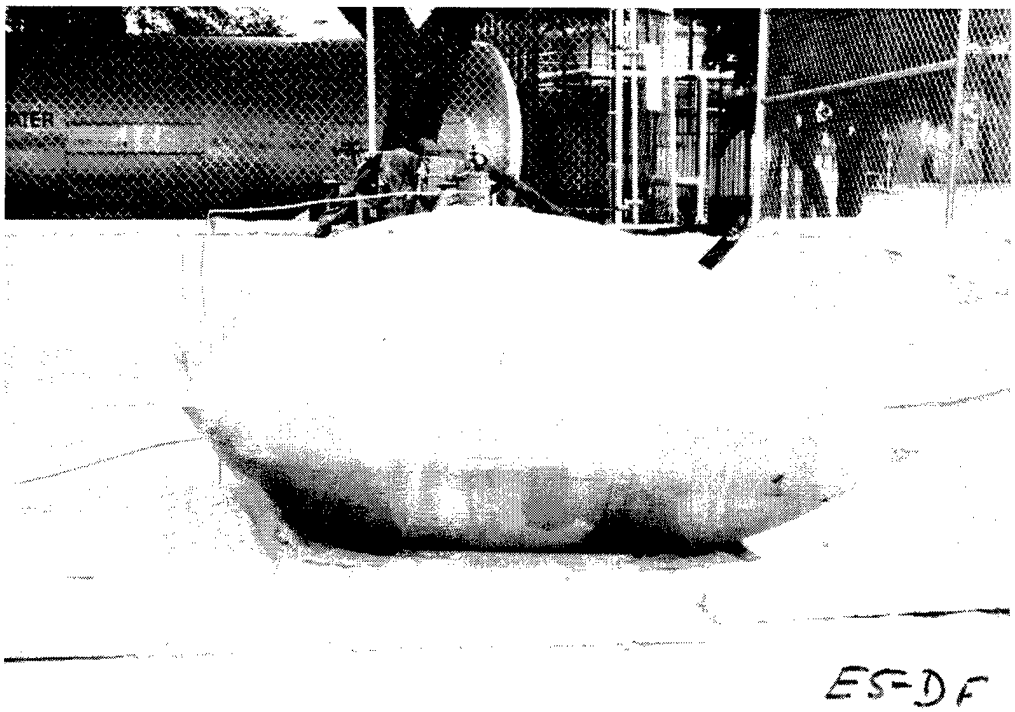
E-5 minitank was filled with diesel fuel and pressurized using the standpipe system during September 1992. Photograph No. 14 was taken within one week after this tank was placed under test conditions. On July 24, 1995, after approximately 34 months under test conditions, a pinhole developed in the fabric at the upper part of the minitank. Due to the internal pressure, a very small stream of fuel began to spray to the height of 12 to 15 cm (5 to 6 in.). Even after approximately 265 L (70 gal.) of diesel fuel was removed from the tank, the fuel kept oozing from the pinhole. Concurrently, 1- to 2-mm diameter fish scale type blemishes were also observed over the entire surface of the minitank, indicating delamination of the elastomeric

coating from the supporting fabric. The condition of this tank and the escaping large quantities of diesel fuel are shown in Photograph No. 15. Due to the imminent failure of this minitank, for safety and environmental concerns, and because of the excessive cost of potential cleanup, the diesel fuel was withdrawn from the tank.

Photograph No. 14. E-5 minitank filled with diesel fuel one week after tank was placed under test conditions

Photograph No. 15. Evidence of E-5 minitank diesel fuel leakage

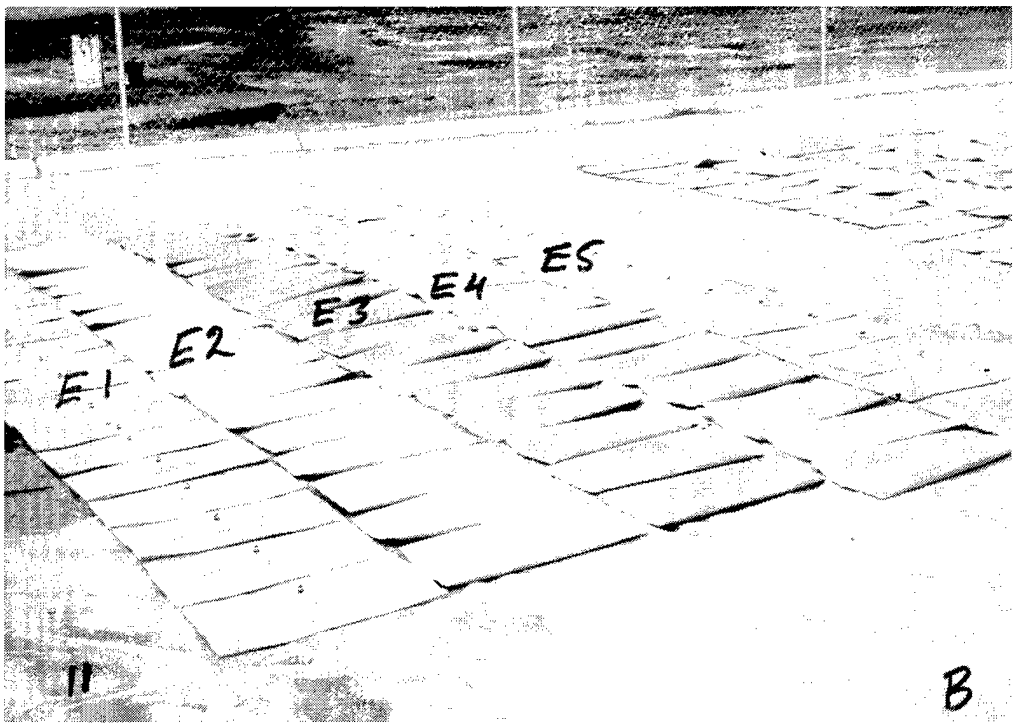
The described visual observations were documented by photographs presented as Photograph Nos. 16 through 21. Photograph Nos. 16 to 18 show the newly deployed (a) empty or blank, (b) turbine fuel-filled, and (c) diesel fuel-filled sacrificial pillow tanks, respectively, while Photograph Nos. 19 to 21 show the same set of sacrificial pillow tanks during June 1994, *i.e.*, approximately two years after deployment. Three of the diesel fuel-containing E-2 minitanks exhibited major delamination of the coating polymer from the nylon fabric. One such pillow tank is pictured in Photograph No. 22.

Photograph No. 16. Empty (blank) sacrificial pillow tanks

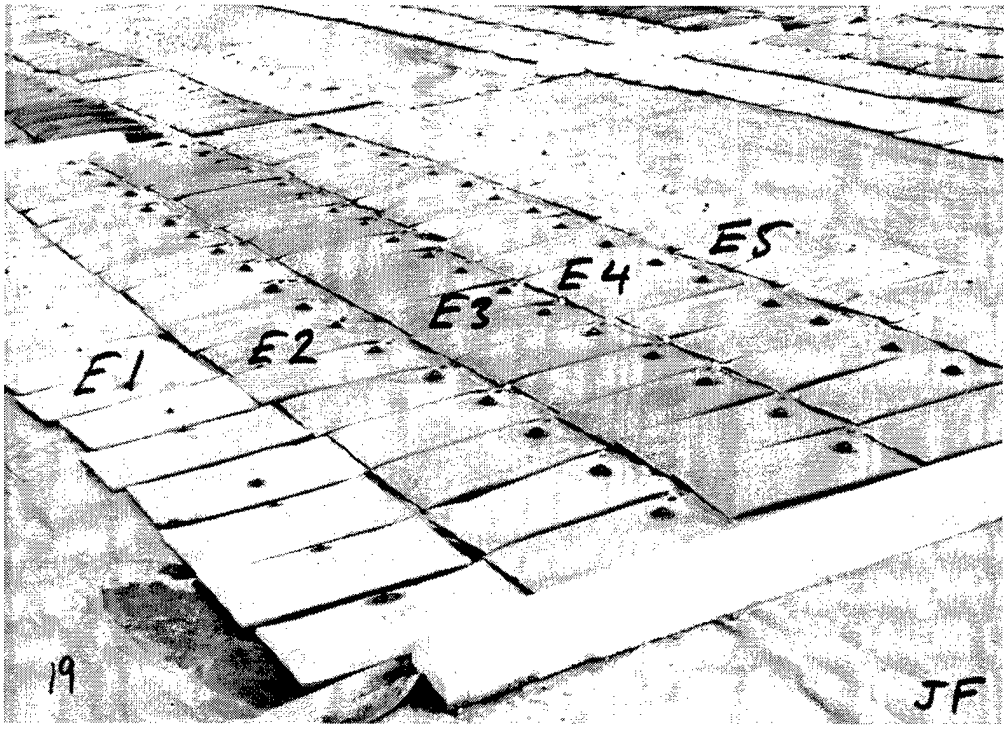
Photograph No. 17. Turbine fuel-filled sacrificial pillow tanks

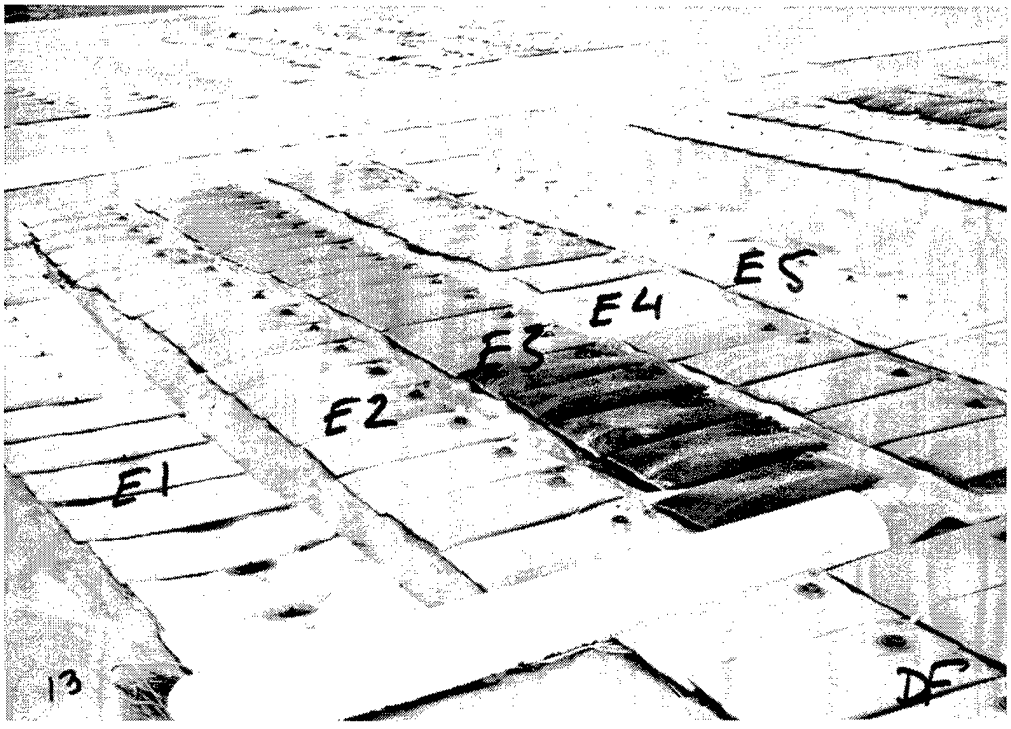
Photograph No. 18. Diesel fuel-filled sacrificial pillow tanks

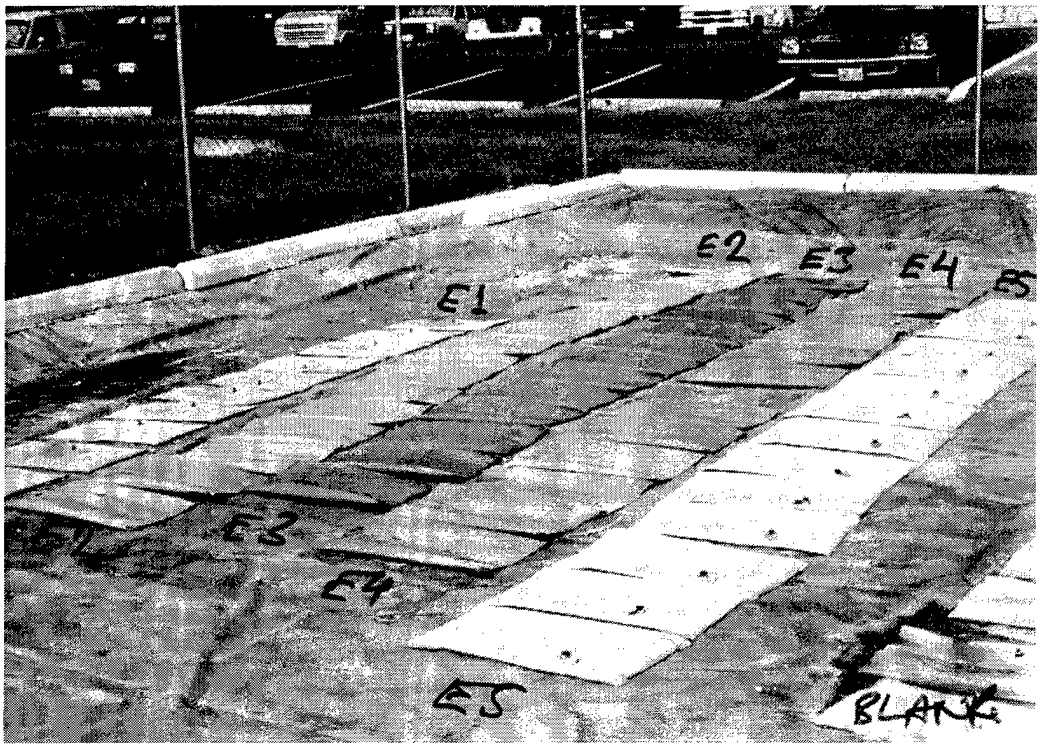
Photograph No. 19. Empty (blank) sacrificial pillow tanks two years after deployment

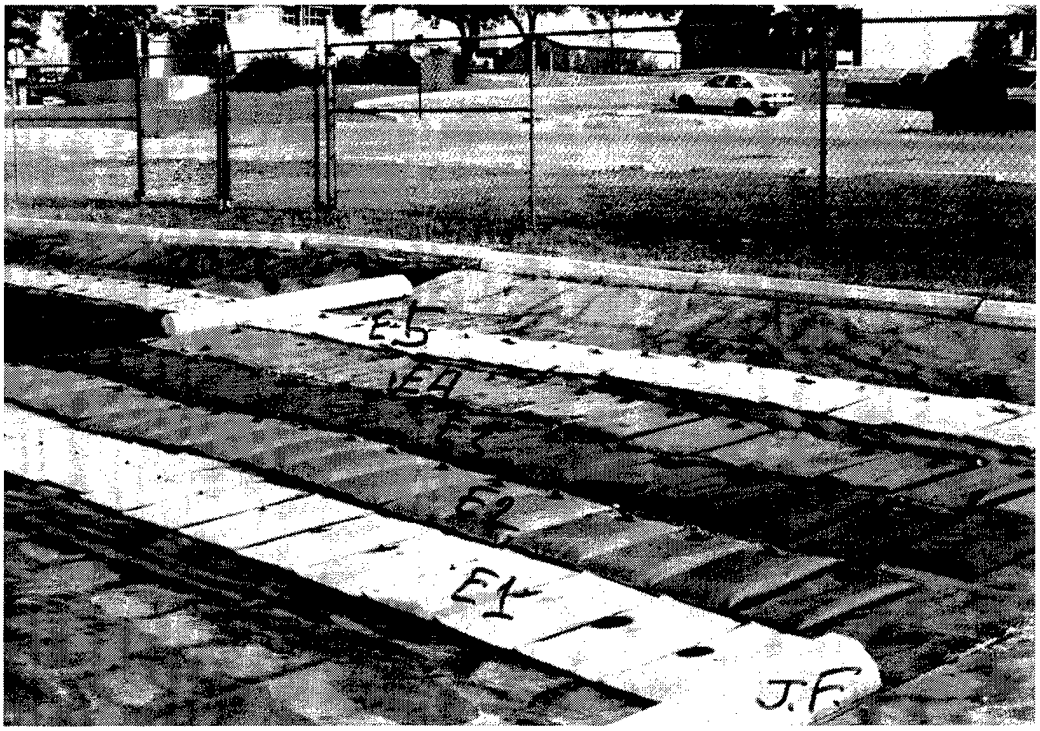
Photograph No. 20. Turbine fuel-filled sacrificial pillow tanks two years after deployment

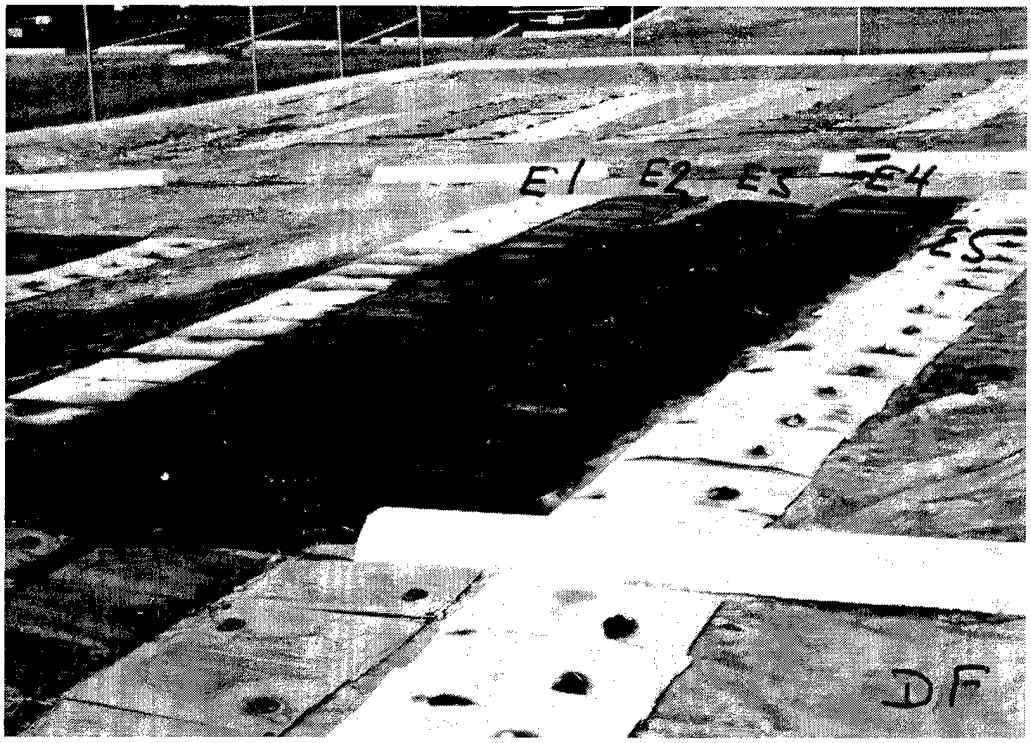
After outdoor storage for approximately 20 to 22 months, during the middle of June 1994, the polyurethane-coated sacrificial pillow tanks that contained referee grade diesel fuel were found to be severely degraded. Within approximately one week, on the previously clean berm liner, several small streams of diesel fuel were observed. Further investigation revealed that most of these small pillow tanks (30 × 60 cm) were empty, and those that still contained diesel fuel split at the seams and spilled diesel fuel onto the berm liner. It should also be noted that these

Photograph No. 21. Diesel fuel-filled sacrificial pillow tanks two years after deployment

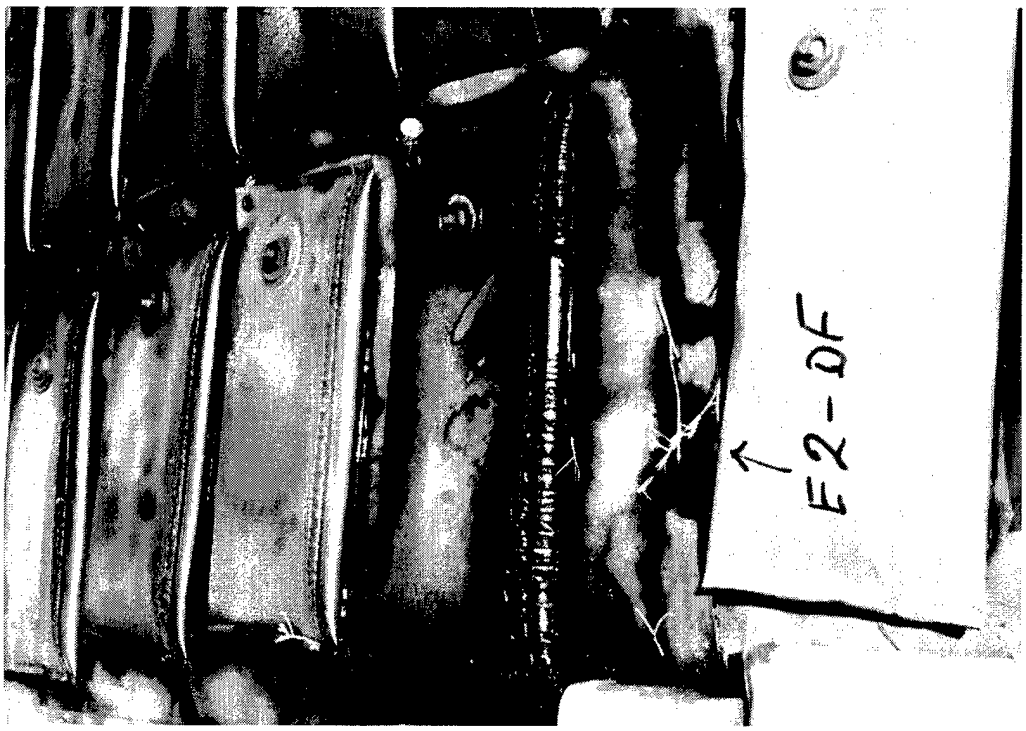
Photograph No. 22. Evidence of delamination of the coating polymer from the nylon fabric of an E-2 sacrificial pillow tank containing diesel fuel

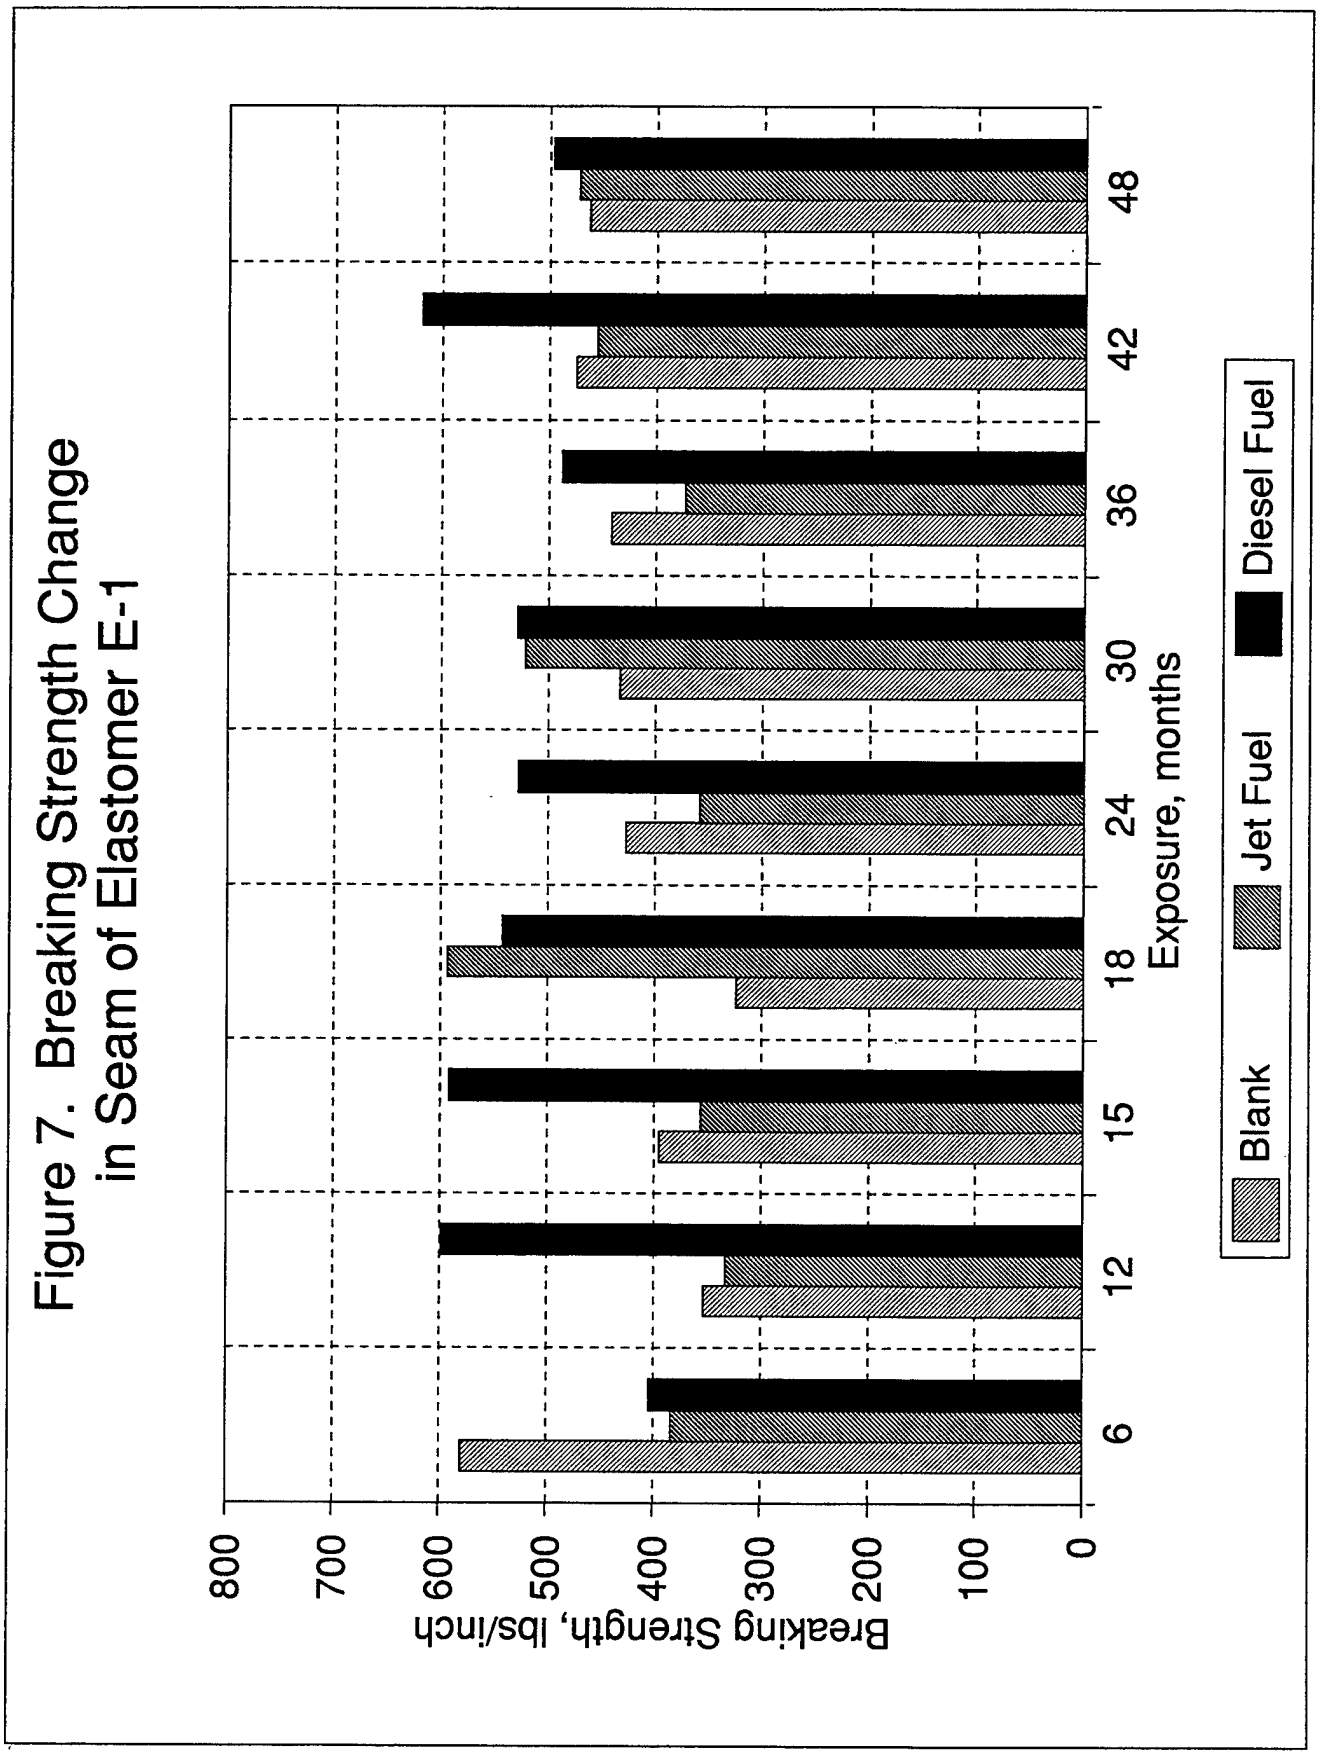
Breaking strength changes in the seam sections of E-1 (Fig. 7) showed that some of the average of measured data was below the required 500 lb/in. value. However, these values remained essentially constant for the entire reported 48 months of outdoor exposure. Peel adhesion values (Fig. 18) of this product remained above the specified 30 lb/in., except for the data obtained after 36 months of exposure, a possible specimen defect.

Figure 7. Breaking Strength Change in Seam of Elastomer E-1
Breaking Strength, lbs/inch
0
100
200
300
400
500
600
700
800
6
12
15
18
24
30
36
42
48
Exposure, months
Blank
Jet Fuel
Diesel Fuel

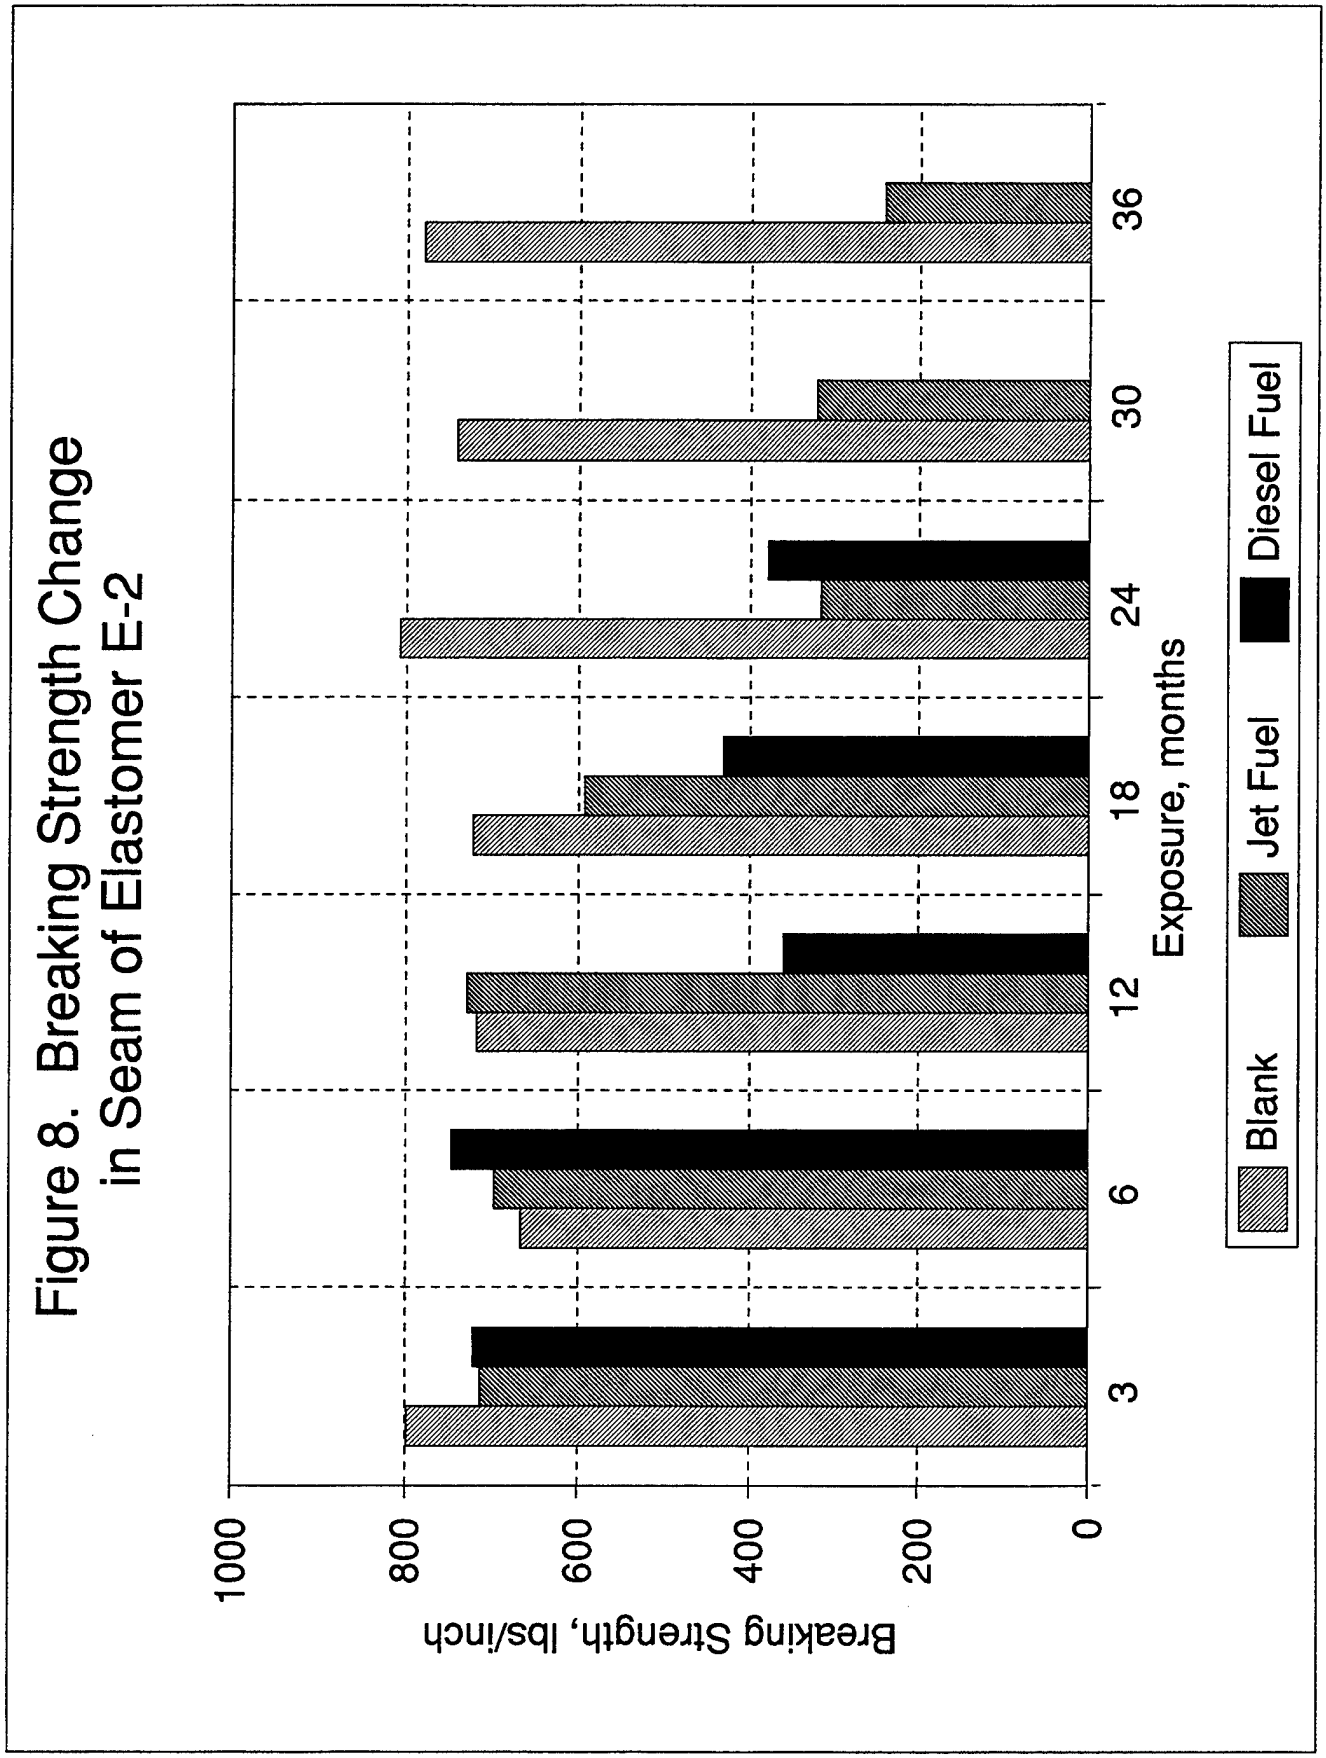
E-2 containing diesel fuel showed degraded breaking strength at 12 months of exposure and complete failure between 24 and 30 months (Fig. 8). Peel adhesion values (Fig. 19) of the 12-month samples dropped below 20 lb/in.

Figure 8. Breaking Strength Change
in Seam of Elastomer E-2
Breaking Strength, lbs/inch
1000
800
600
400
200
0
3
6
12
18
24
30
36
Exposure, months
Blank
Jet Fuel
Diesel Fuel
